1. AGENCY USE ONLY (Leave blank)		2. REPORT DATE 8/19/96		3. REPORT TYPE AND DATES COVERED Final April, 1993 - March, 1996	
4. TITLE AND SUBTITLE OF REPORT Charge state of Ge-related point defects in oxidized SiGe Alloys				5. FUNDING NUMBERS G N0014-93-1-0777 G N0014-93-1-0777

Charge State of Ge-Related Point Defects in Oxidized SiGe Alloys

M.E. Zvanut, PI  
University of Alabama at Birmingham  
Birmingham, AL 35294-1170

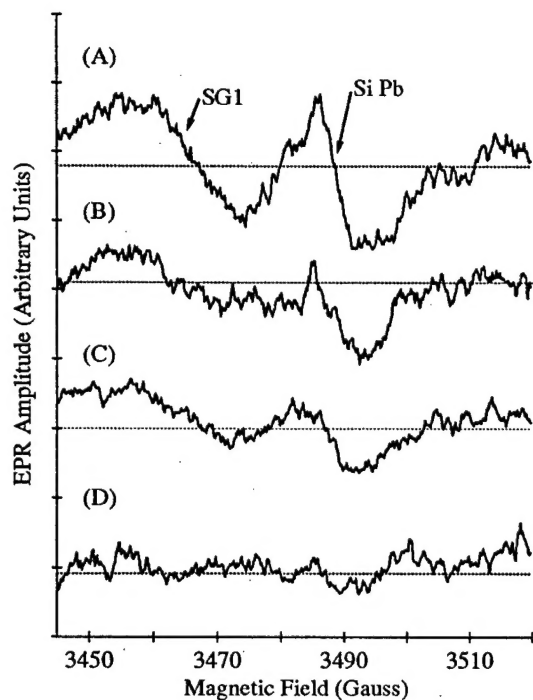
Figure 1. EPR spectra obtained after:  
 (A) growth of 40 nm anchor oxide  
 (B) 15 min KOH etch  
 (C) 20 min KOH and 2.75 min HF etch  
 (D) additional 90 min KOH etch

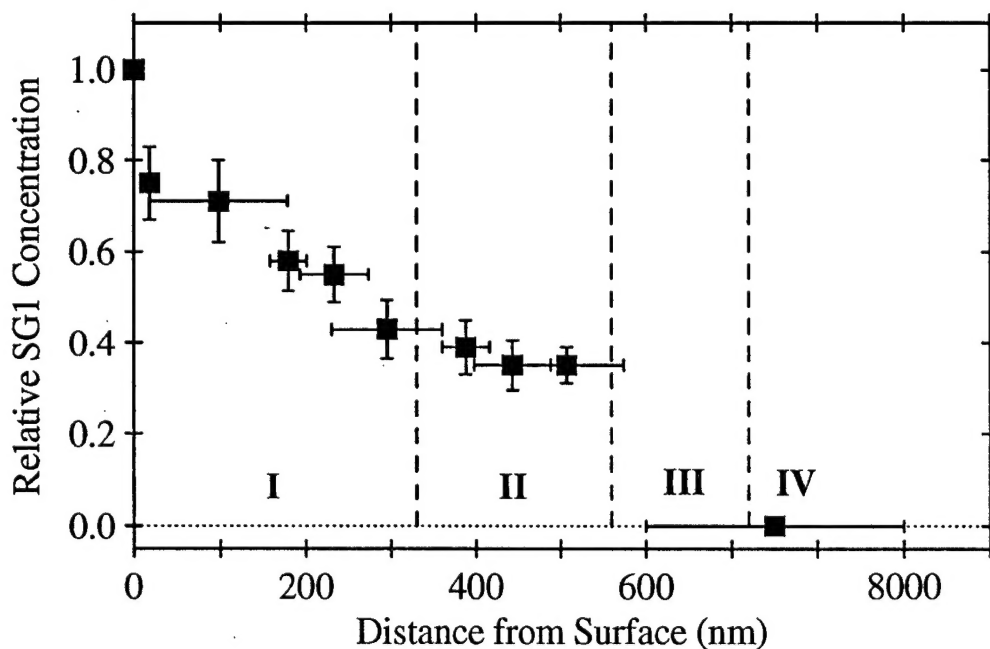
Figure 2. Depth profile for SG1 center; y-axis represents the original surface of the top SiGe layer. I, crystalline SiGe; II, buried oxide; III, damaged SiGe; IV, unimplanted SiGe

The primary result of this work is confirmation that the defect observed in O implanted SiGe is related to the interface between the SiGe and oxide. The center was shown to exhibit properties similar to the interfacial dangling bond observed in Si systems. Thus, the electrically deleterious Si interfacial dangling bond center present in Si/ $\text{SiO}_2$  structures has a Ge analogue in SiGe. This opens the door to the possible existence of a family of interface centers residing in different double-layer semiconductor-insulator structures. Other wide band-gap semiconductors such as SiC and GaN may exhibit similar interfacial dangling bond centers. Given the well-established role of dangling bonds in Si systems, these centers should be thoroughly addressed in the alternative semiconductor-dielectric systems.
